Bubbles

Comparing TRWKR term with after stopping of TRWKR
 5th stage : with TRWKR, No rain : previous day and current day
 7th stage : after stopping of TRWKR, No rain : previous day and current day

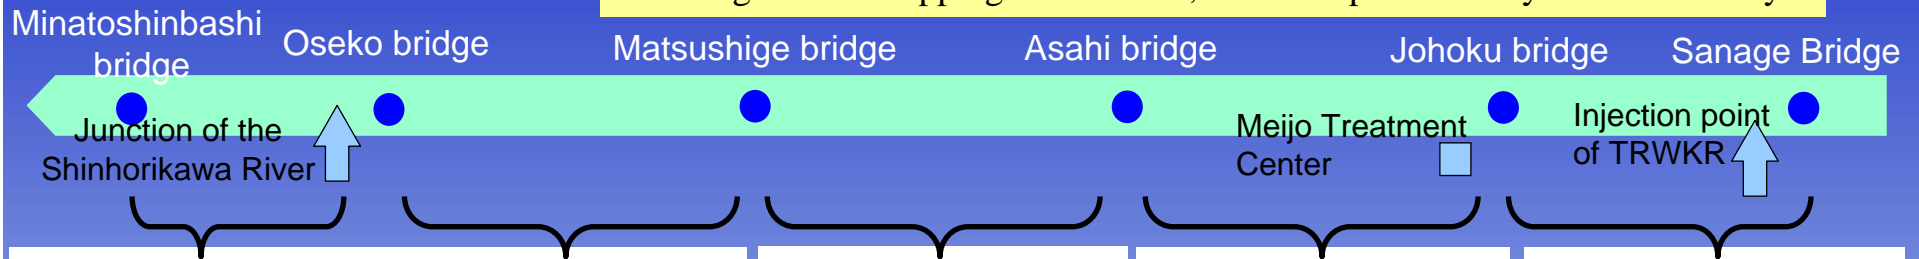
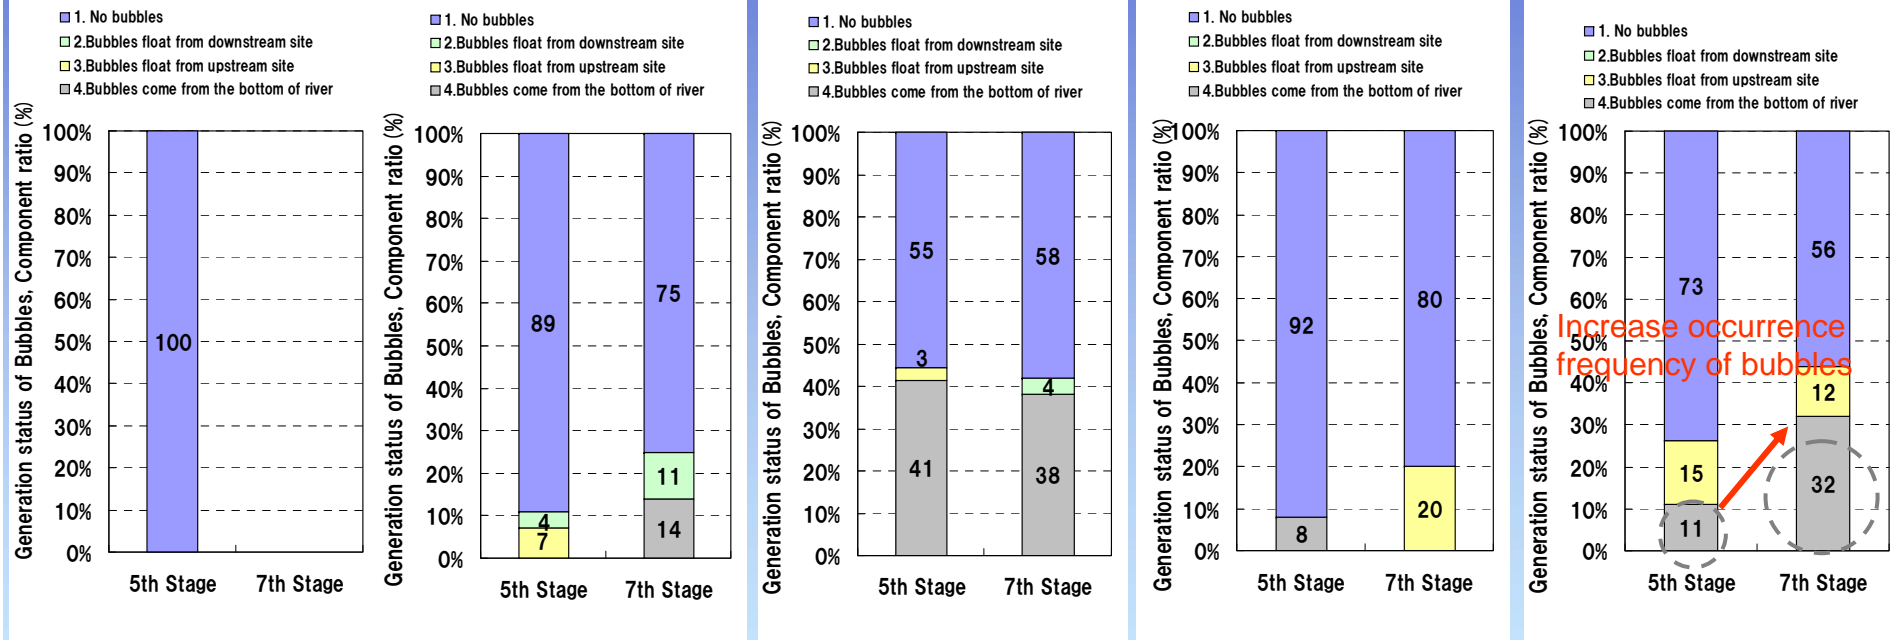
Bubbles from the bottom increased after stopping TRWKR.
 In this area, it was confirmed that the condition of bubbles improved at 5th stage.
